Coal Combustion Waste Impoundment

Round 5 - Dam Assessment Report

Winyah Generating Station (Site #004)

Santee Cooper

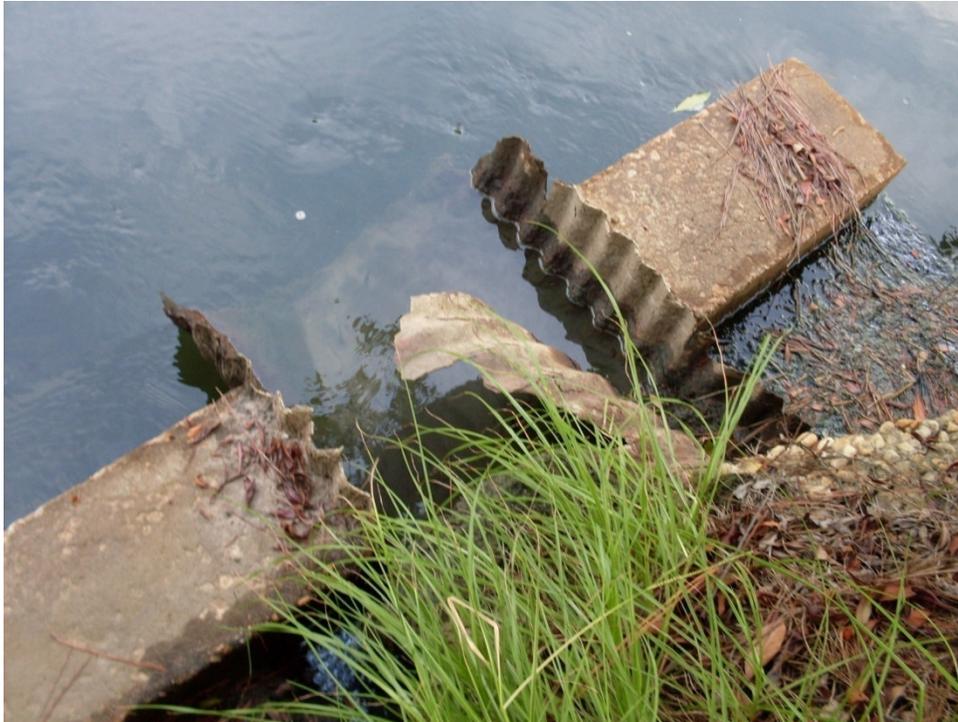
Depressions (“dropouts”) along the abandoned discharge pipe of Ash Pond A through the perimeter dam were observed. The depressions are possibly associated with structural failure of the pipe due to corrosion of a CMP section of the abandoned discharge pipe between the toe of the dam and the Discharge Canal and/or due to joint separations. (It is not known if the CMP section continues through the perimeter dike to the intake riser.) Depressions with some exposed gravel along the Ash Pond B discharge pipe (RCP) through the perimeter dam were observed in the section between the toe of the dam and the Discharge Canal. The depressions were observed to be due to loss of overburden soil into separations at joints in the discharge pipe. As previously noted in Subsection 1.1.1, Santee Cooper should investigate both of these penetrations and implement appropriate remedial actions, as needed.

Photo BA-17: Failed CMP Outfall of Abandoned Decant Tower Drain Through West Dike of Ash Pond A – Viewed at Discharge Canal.

separated joints and soil loss over the pipe, poses a potential threat to the stability of the perimeter dike. The abandoned outlet pipe through the Ash Pond A perimeter dike may also pose a threat to the stability of the perimeter dike, if the severely corroded CMP section observed at the outfall continues all the way back through the dike to the riser structure. Santee Cooper should investigate both of these penetrations and implement appropriate remedial actions, as needed.

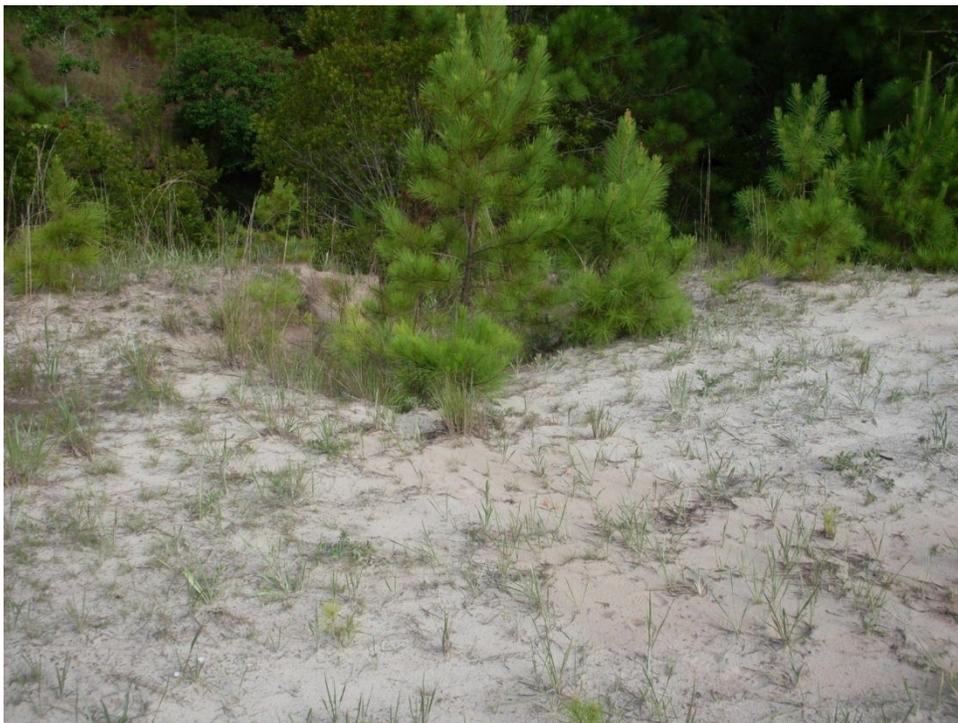
Photo BA-18: Depression in Ground Along Centerline of Failed CMP Outfall of Abandoned Decant Tower Drain Through West Dike of Ash Pond A.

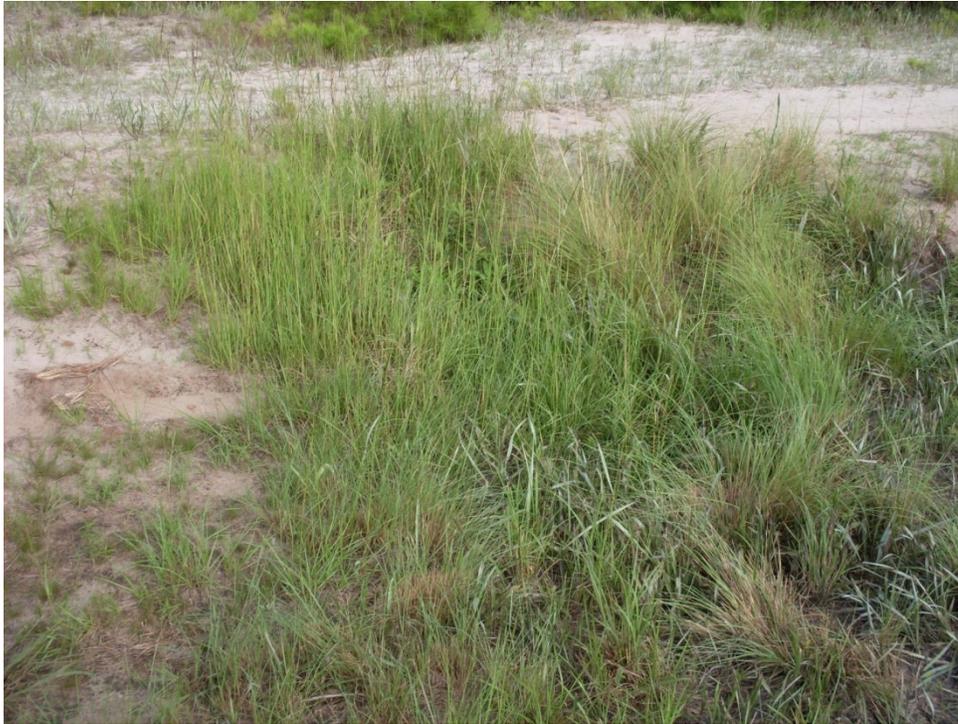
Photo BA-19: Additional Depression in Ground Along Centerline of Failed CMP Outfall of Abandoned Decant Tower Drain Through West Dike of Ash Pond A.

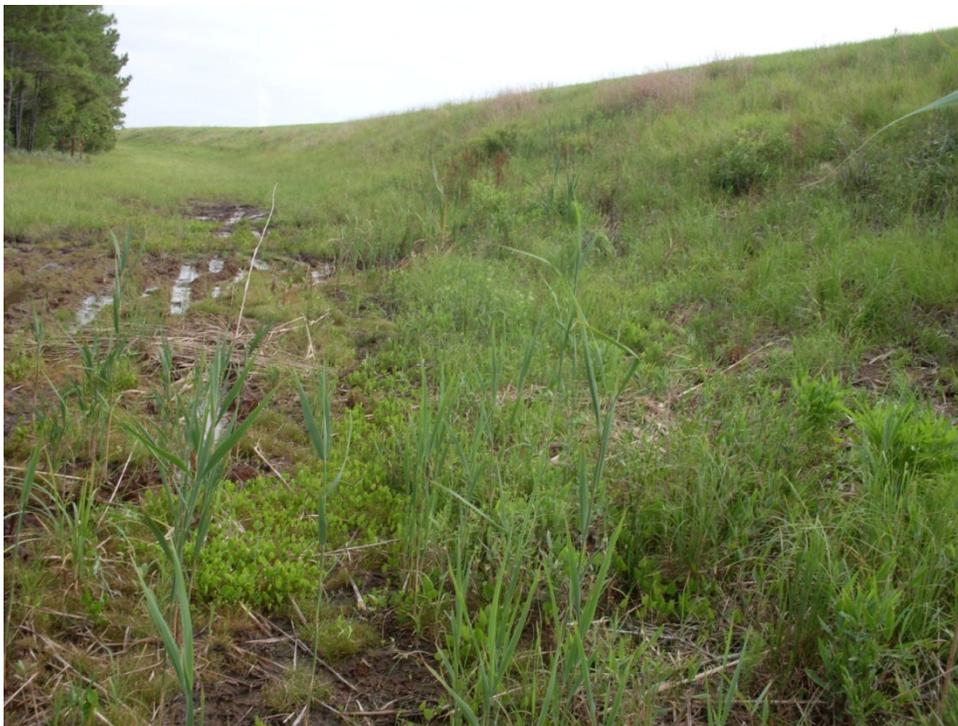
Photo BB-8: Outside Toe of Perimeter Dike West Side of Ash Pond B Decant Tower North of Buried Outfall Drain Pipe – View North.

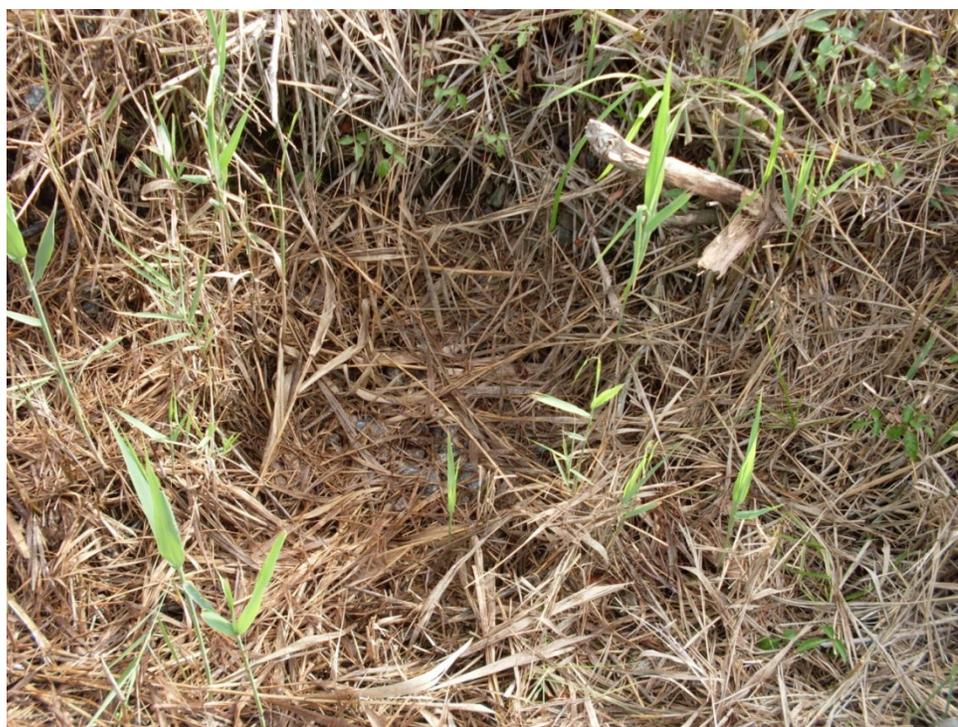
With exception of the RCP discharge conduit at Ash Pond B, the principal outlet structures, located at Ash Pond B (riser intake only) and the South Ash Pond, appear to be in sound and stable condition. The Ash Pond B RCP, which has

Photo BB-9: Depression and Exposed Gravel (Under Grass) Upstream of Ash Pond B Drain Outfall. (Apparent Separation at Last Joint in RCP).

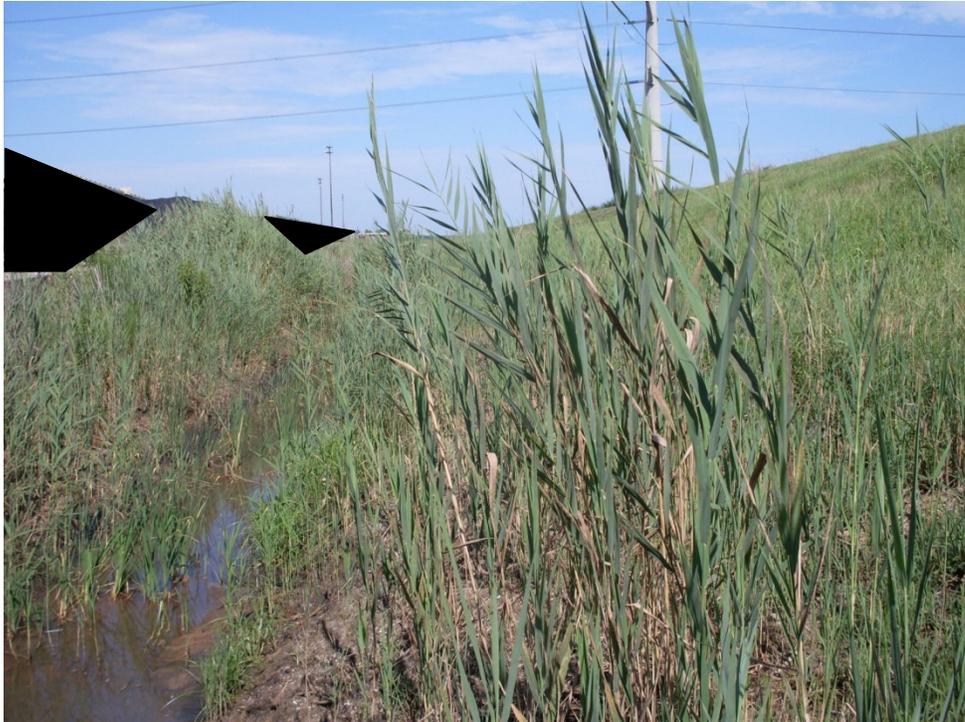
Photo BS-14: Ditch Along Outside Toe of Perimeter Dike North Side of South Ash Pond – Viewed East.

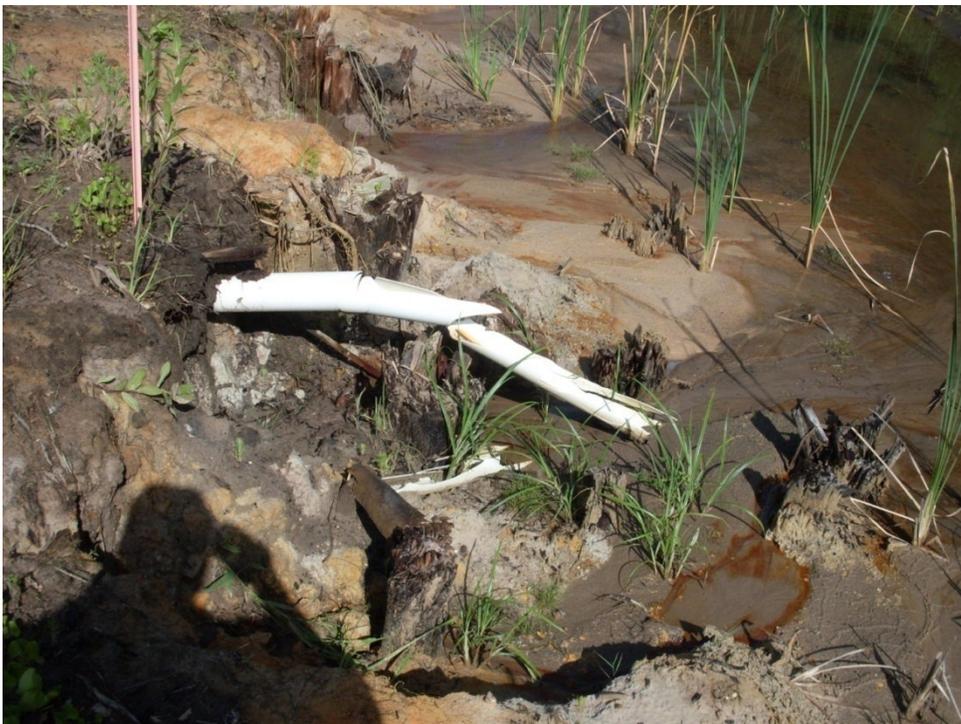
Some areas of poor grass cover were noted, particularly in toe areas where recent work on the toe drain outlets had been conducted. These areas should be reseeded as part of routine maintenance or otherwise protected with an inverted filter in the wet toe areas if grass cannot be established and maintained.

Photo BS-17: Damaged End of Toe Drain PVC Pipe Outlet at Toe Ditch Exposed by Erosion – Viewed East.

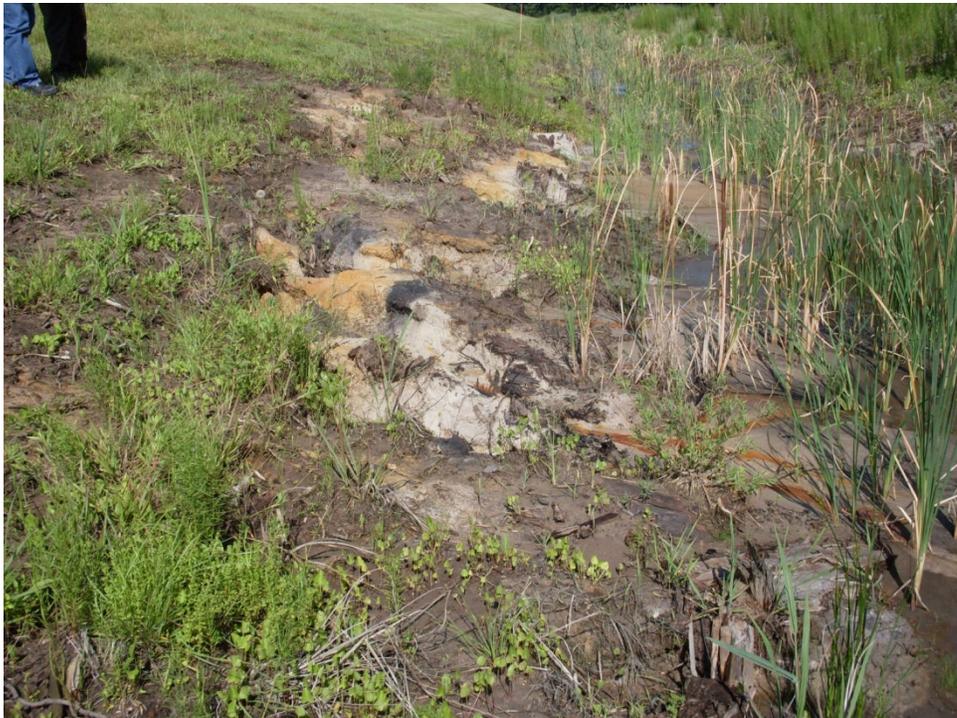
Wet soils and small seeps were observed along the outside toe of the embankment and at the toe drains; the wetness and small seeps appear to be associated with drainage of water collected in the toe drain and gradual seepage through the generally sandy foundation soils. These conditions do not threaten the stability of the perimeter dam at this time but should be visually monitored during routine inspections for any change in condition.

Photo BS-18: Wet Ground and Seepage Along Outside Toe Ditch South Side of South Ash Pond.

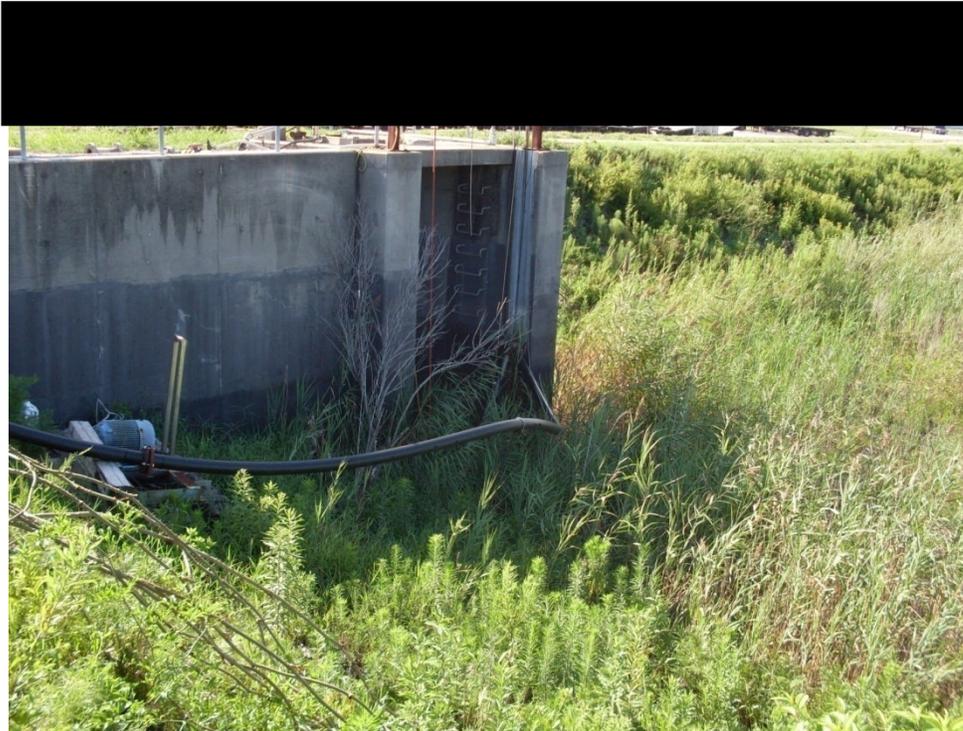
Photo B2-21: View of East Side of Pump Structure of Unit 2 Slurry Pond. (Open Side Formally was Fitted with Wooden Slide Gates to Impound Water in the Pond; Note Normal Water Level Stain on Concrete.)

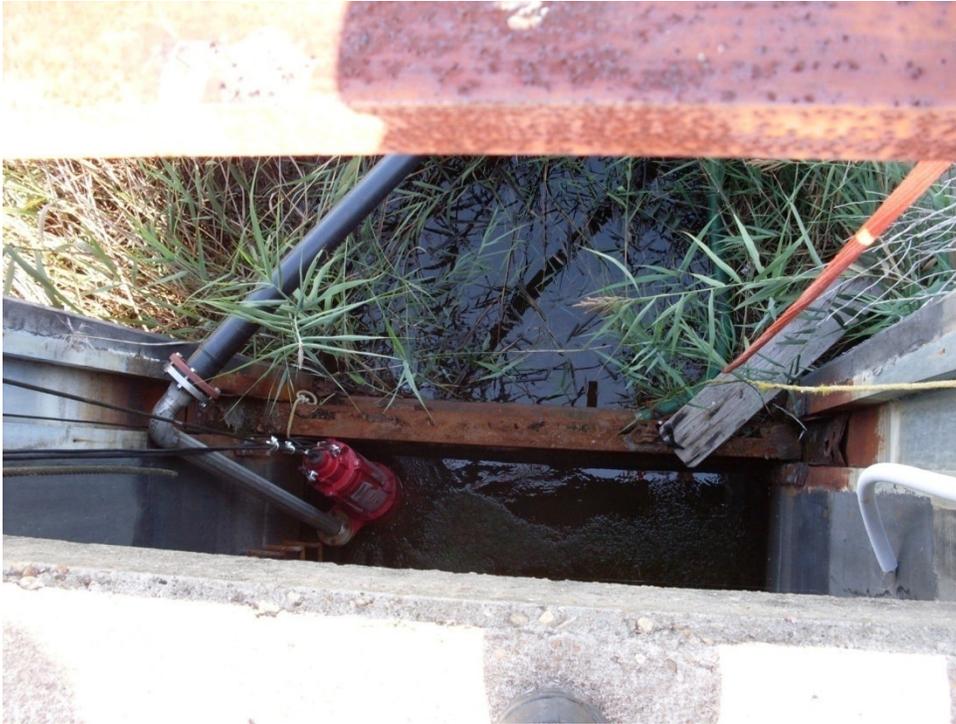
Photo B2-22: View of Pump Placed Inside of Pump Structure of Unit 2 Slurry Pond. (Note Bottom Section of Slide Gate is Raised Slightly.)
